RC
1042
.M38
1990a
c.2

Department
of Transportation
National Highway
Traffic Safety
Administration

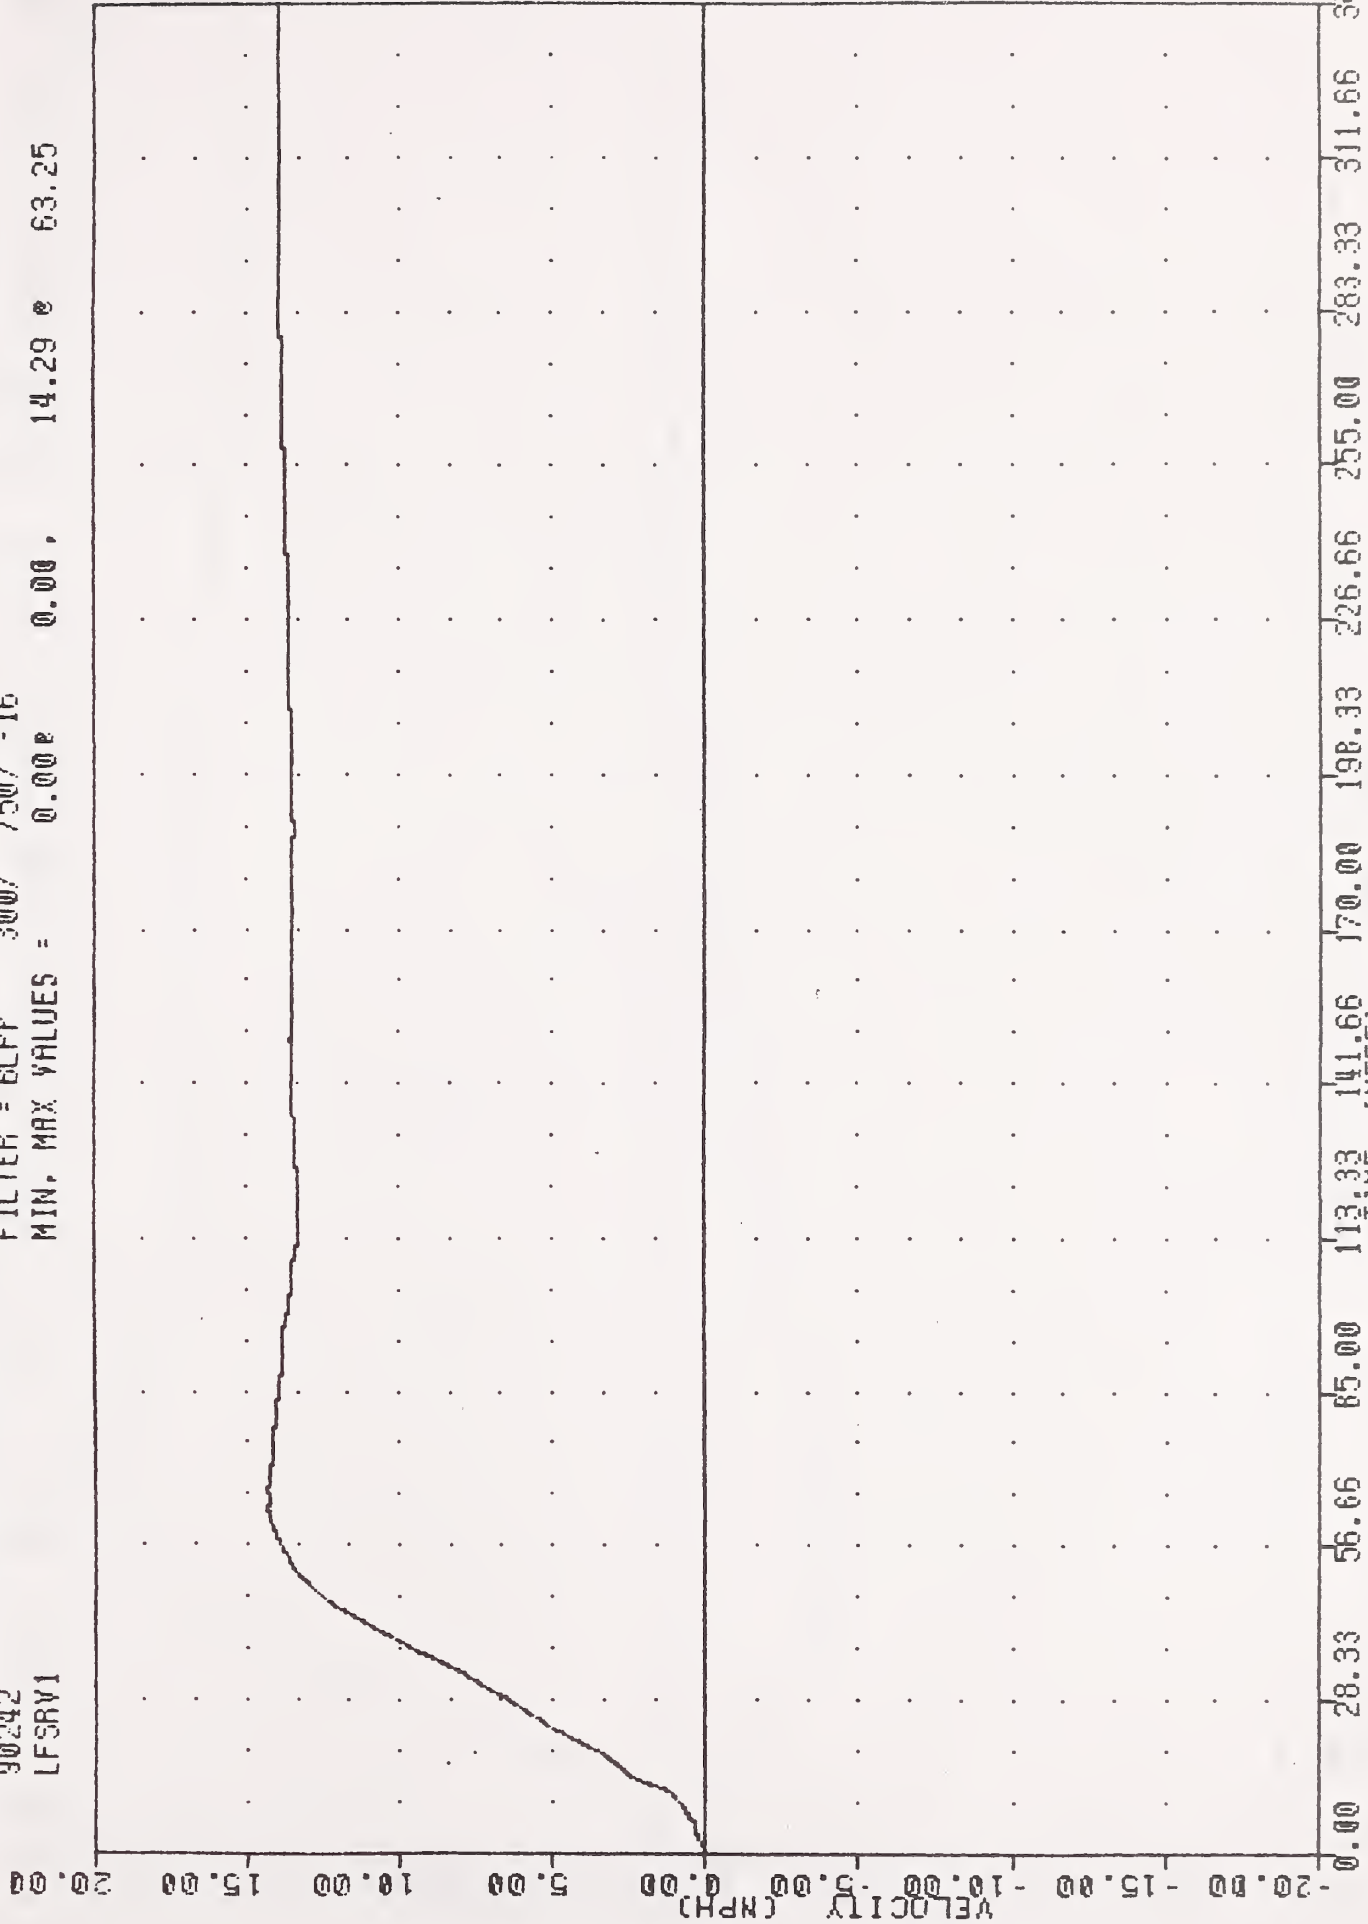
CONTOURED MOVING BARRIER INTO FORD ESCORT AT 28.3 MPH *3
 LEFT FRONT SILL RESULTANT VELOCITY

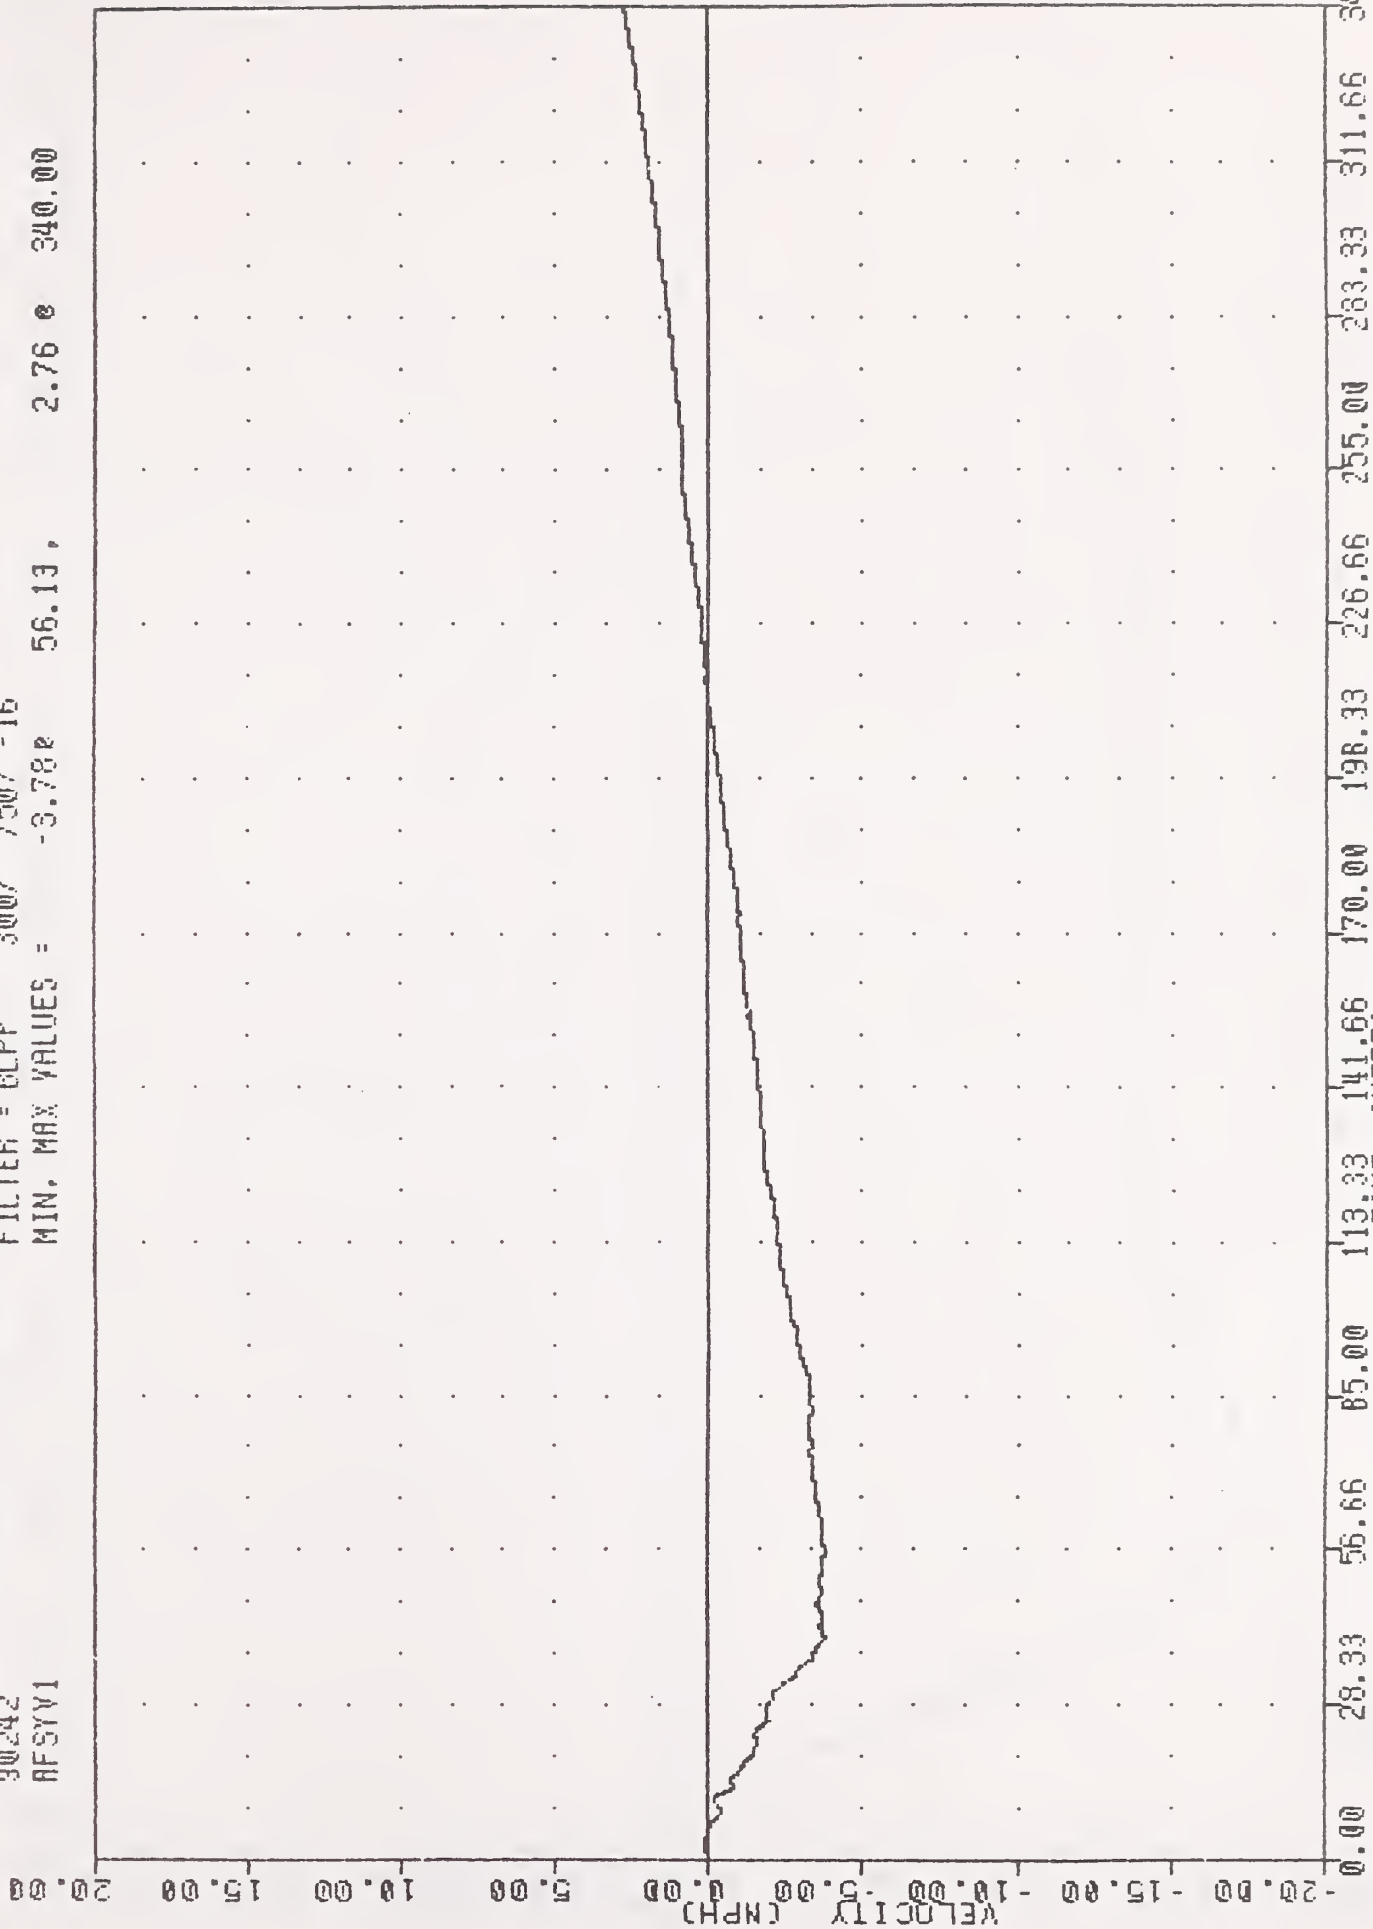
CONTOURED MOVING BARRIER INTO FORD ESCORT AT 28.3 MPH #3
 RIGHT FRONT SILL Y-AXIS VELOCITY

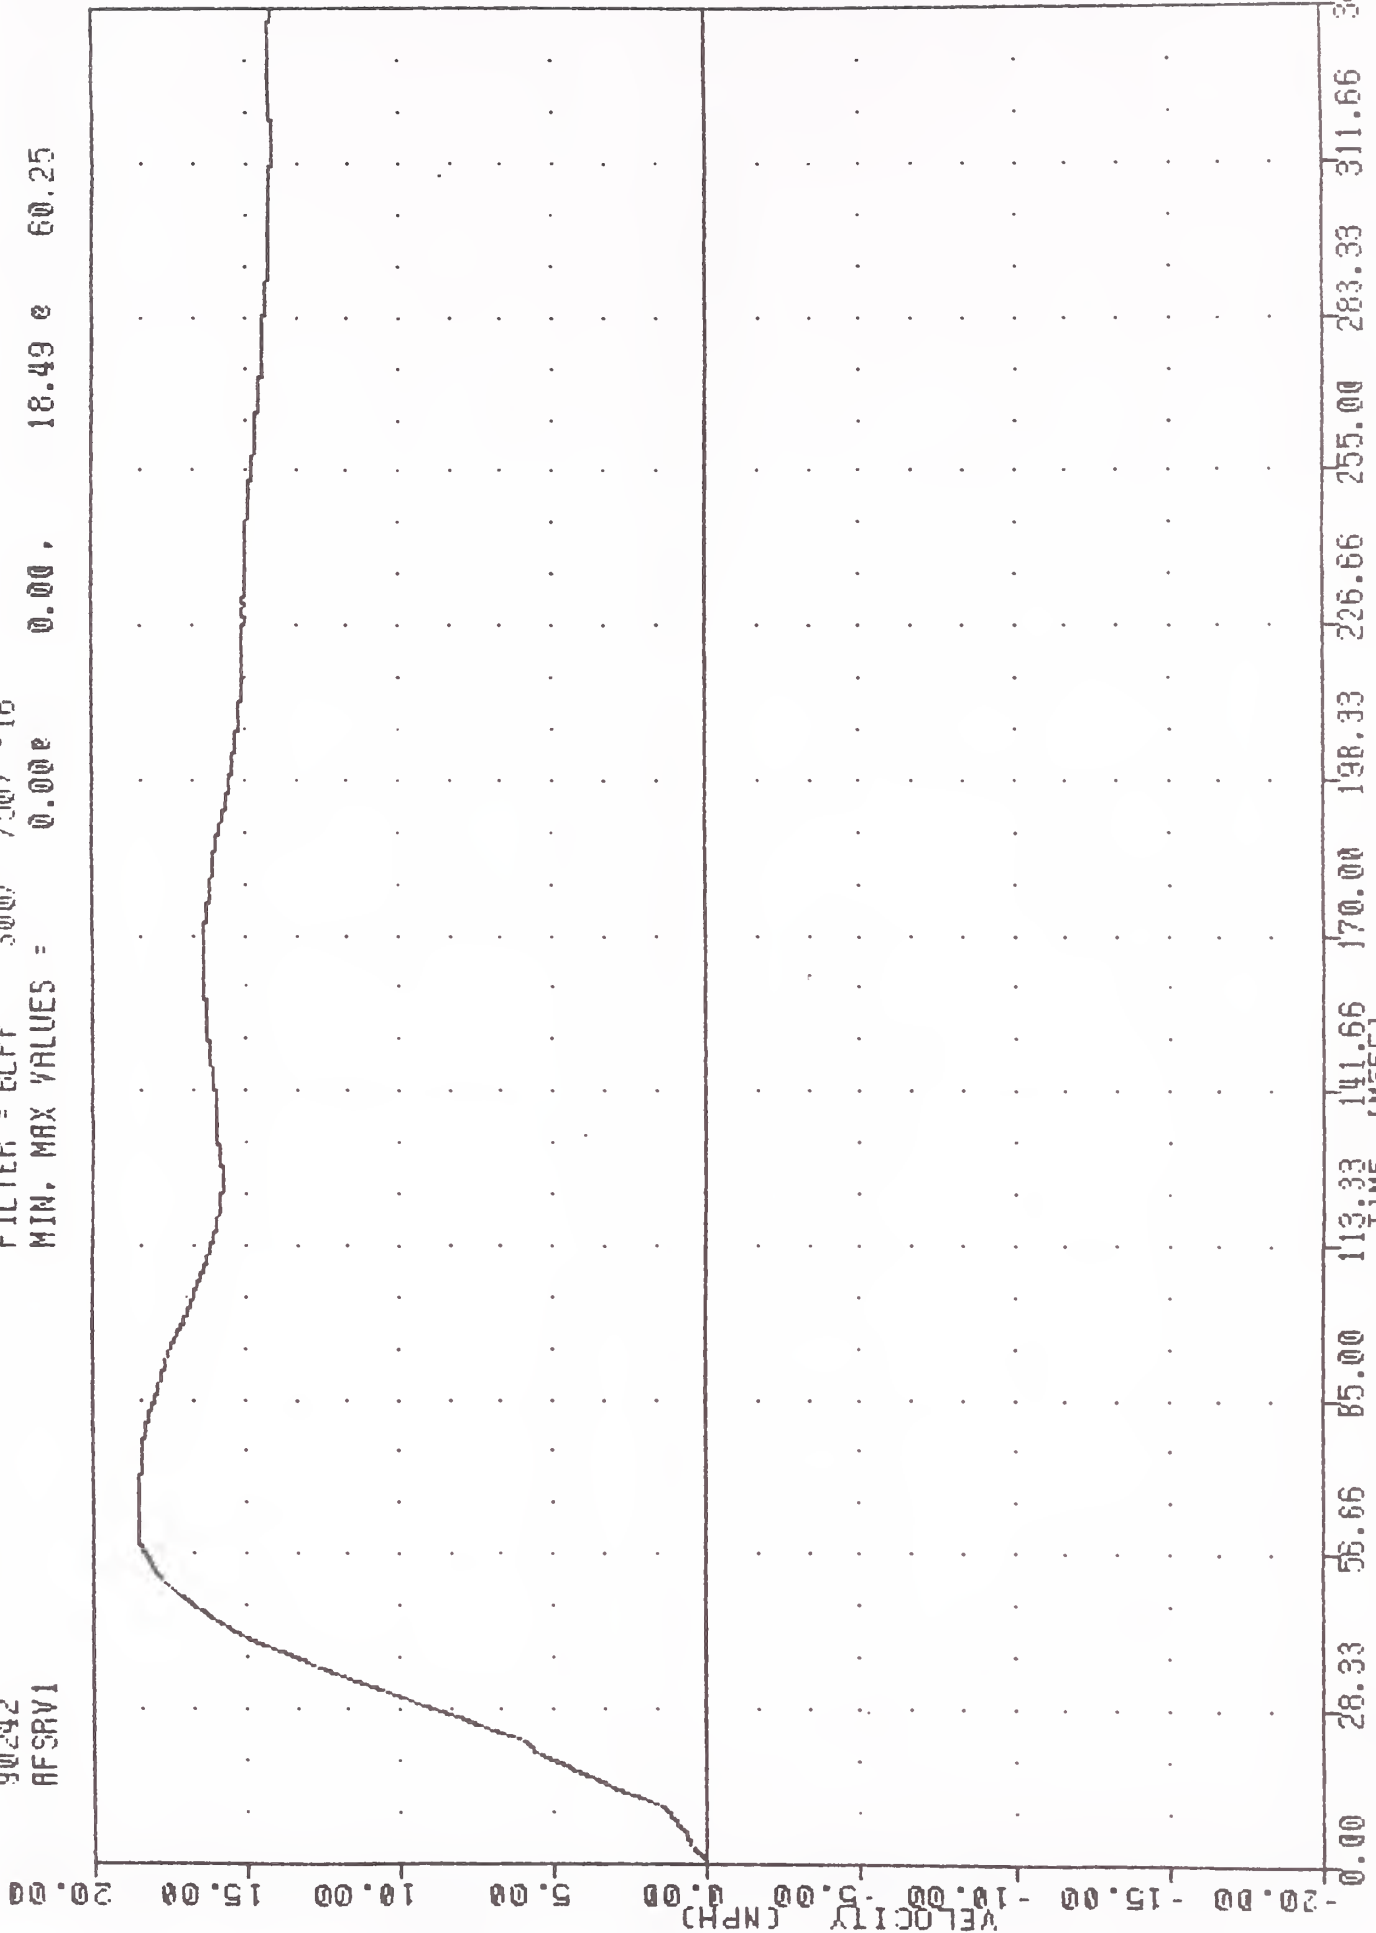
CONTOURED MOVING BARRIER INTO FORD ESCORT AT 28.3 MPH #3
 RIGHT FRONT SILL RESULTANT VELOCITY

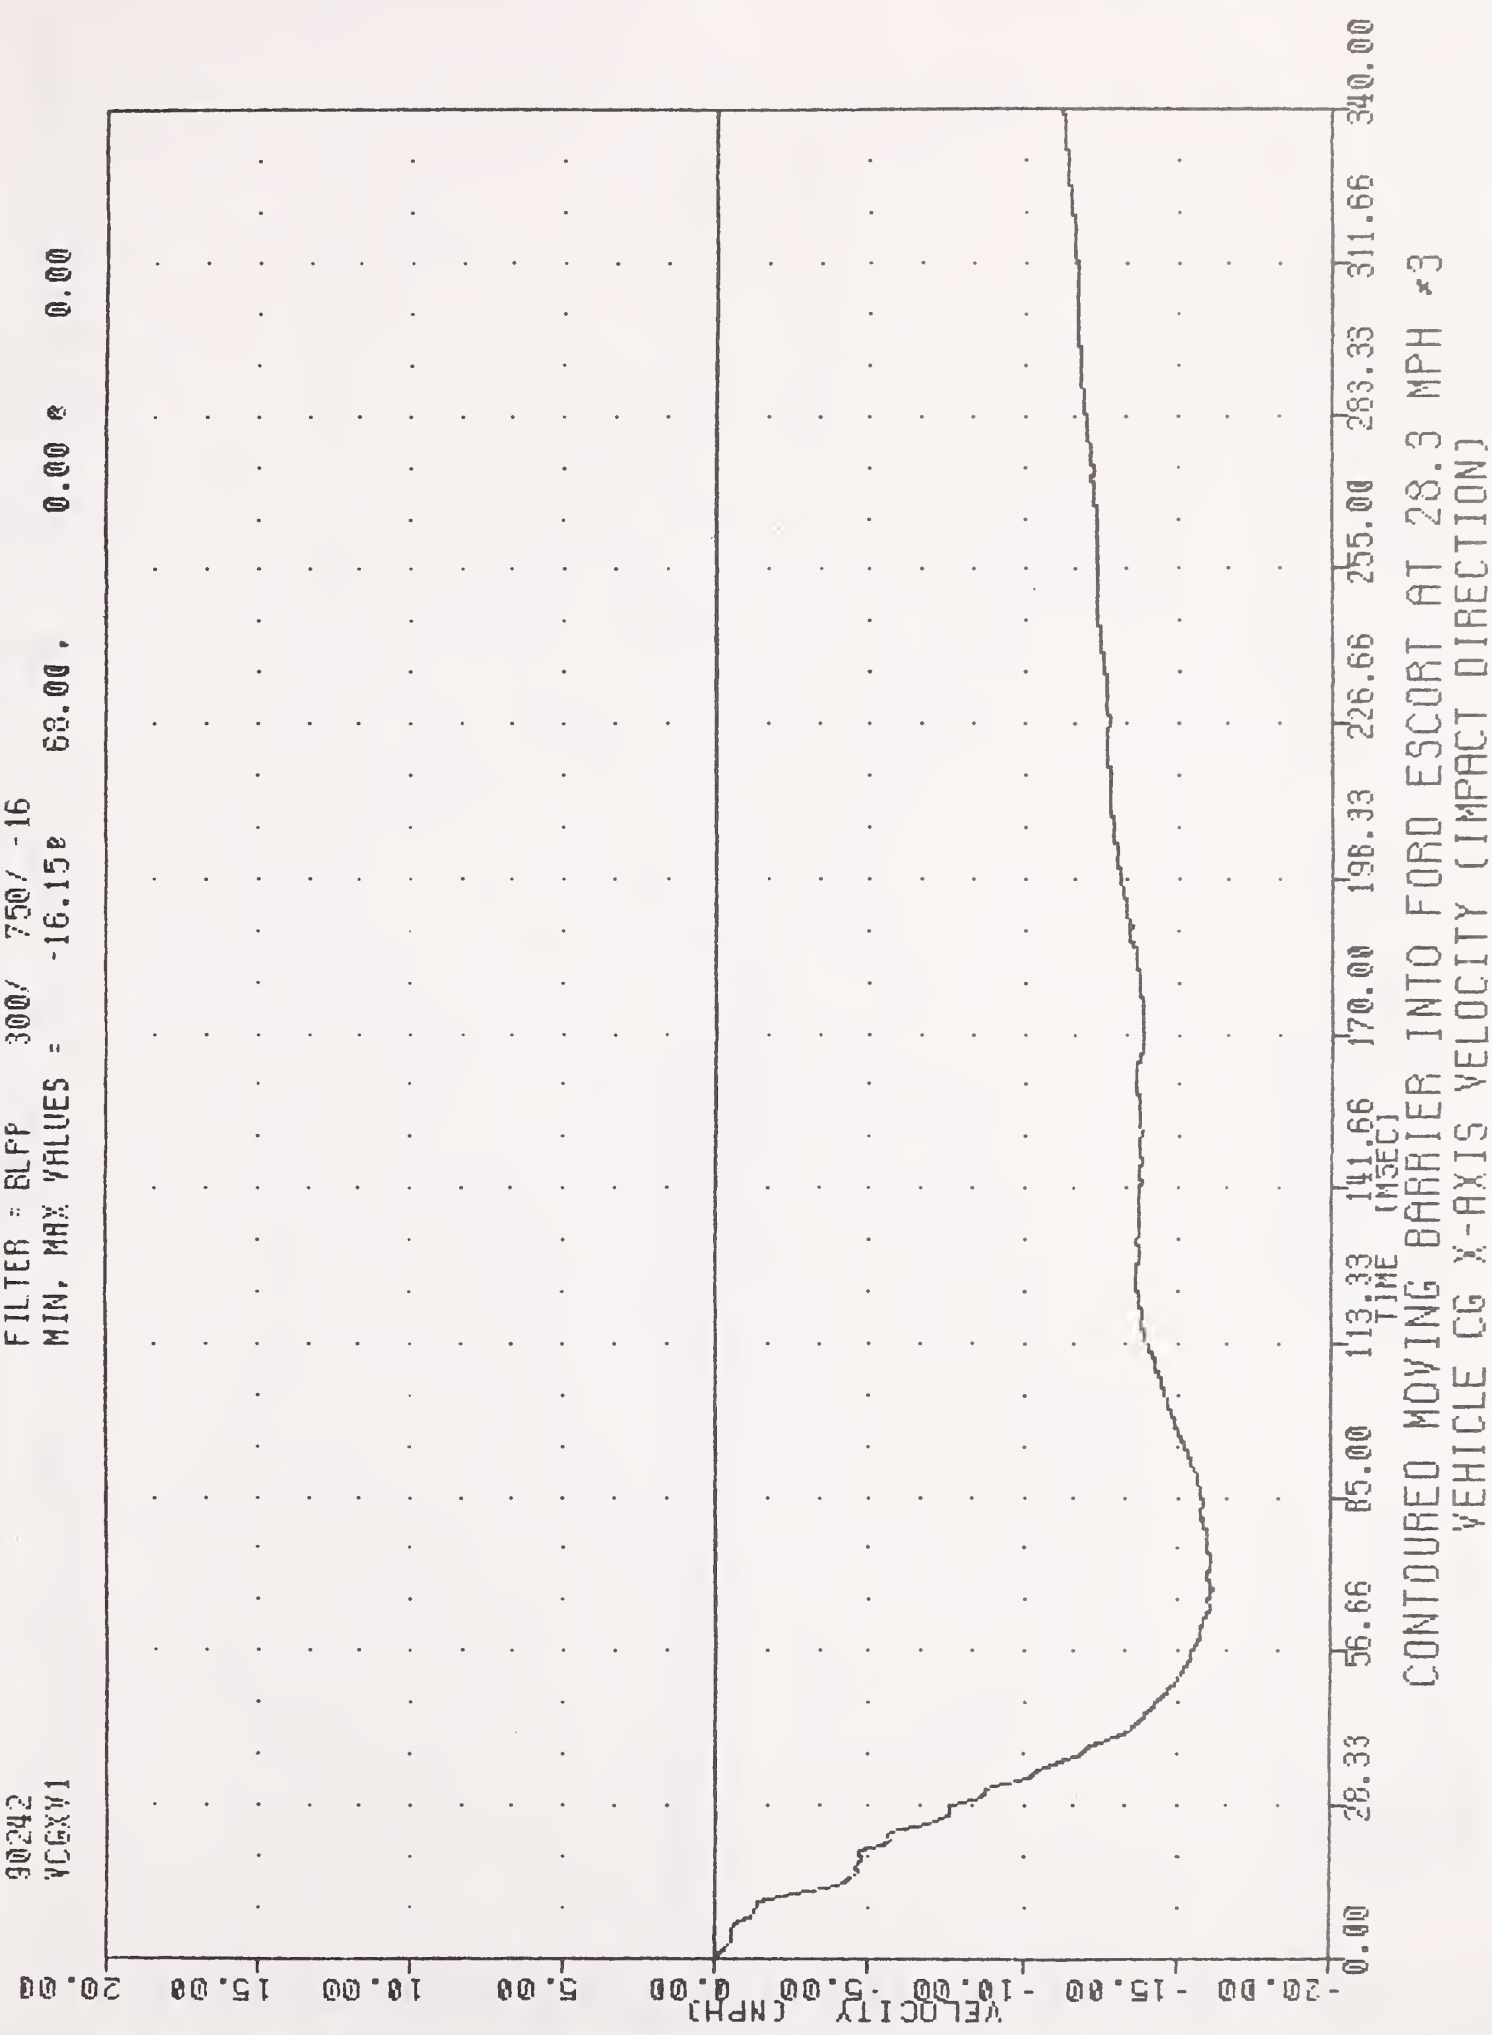
CONTOURED MOVING BARRIER INTO FORD ESCORT AT 28.3 MPH *3
 VEHICLE CG X-AXIS VELOCITY (IMPACT DIRECTION)

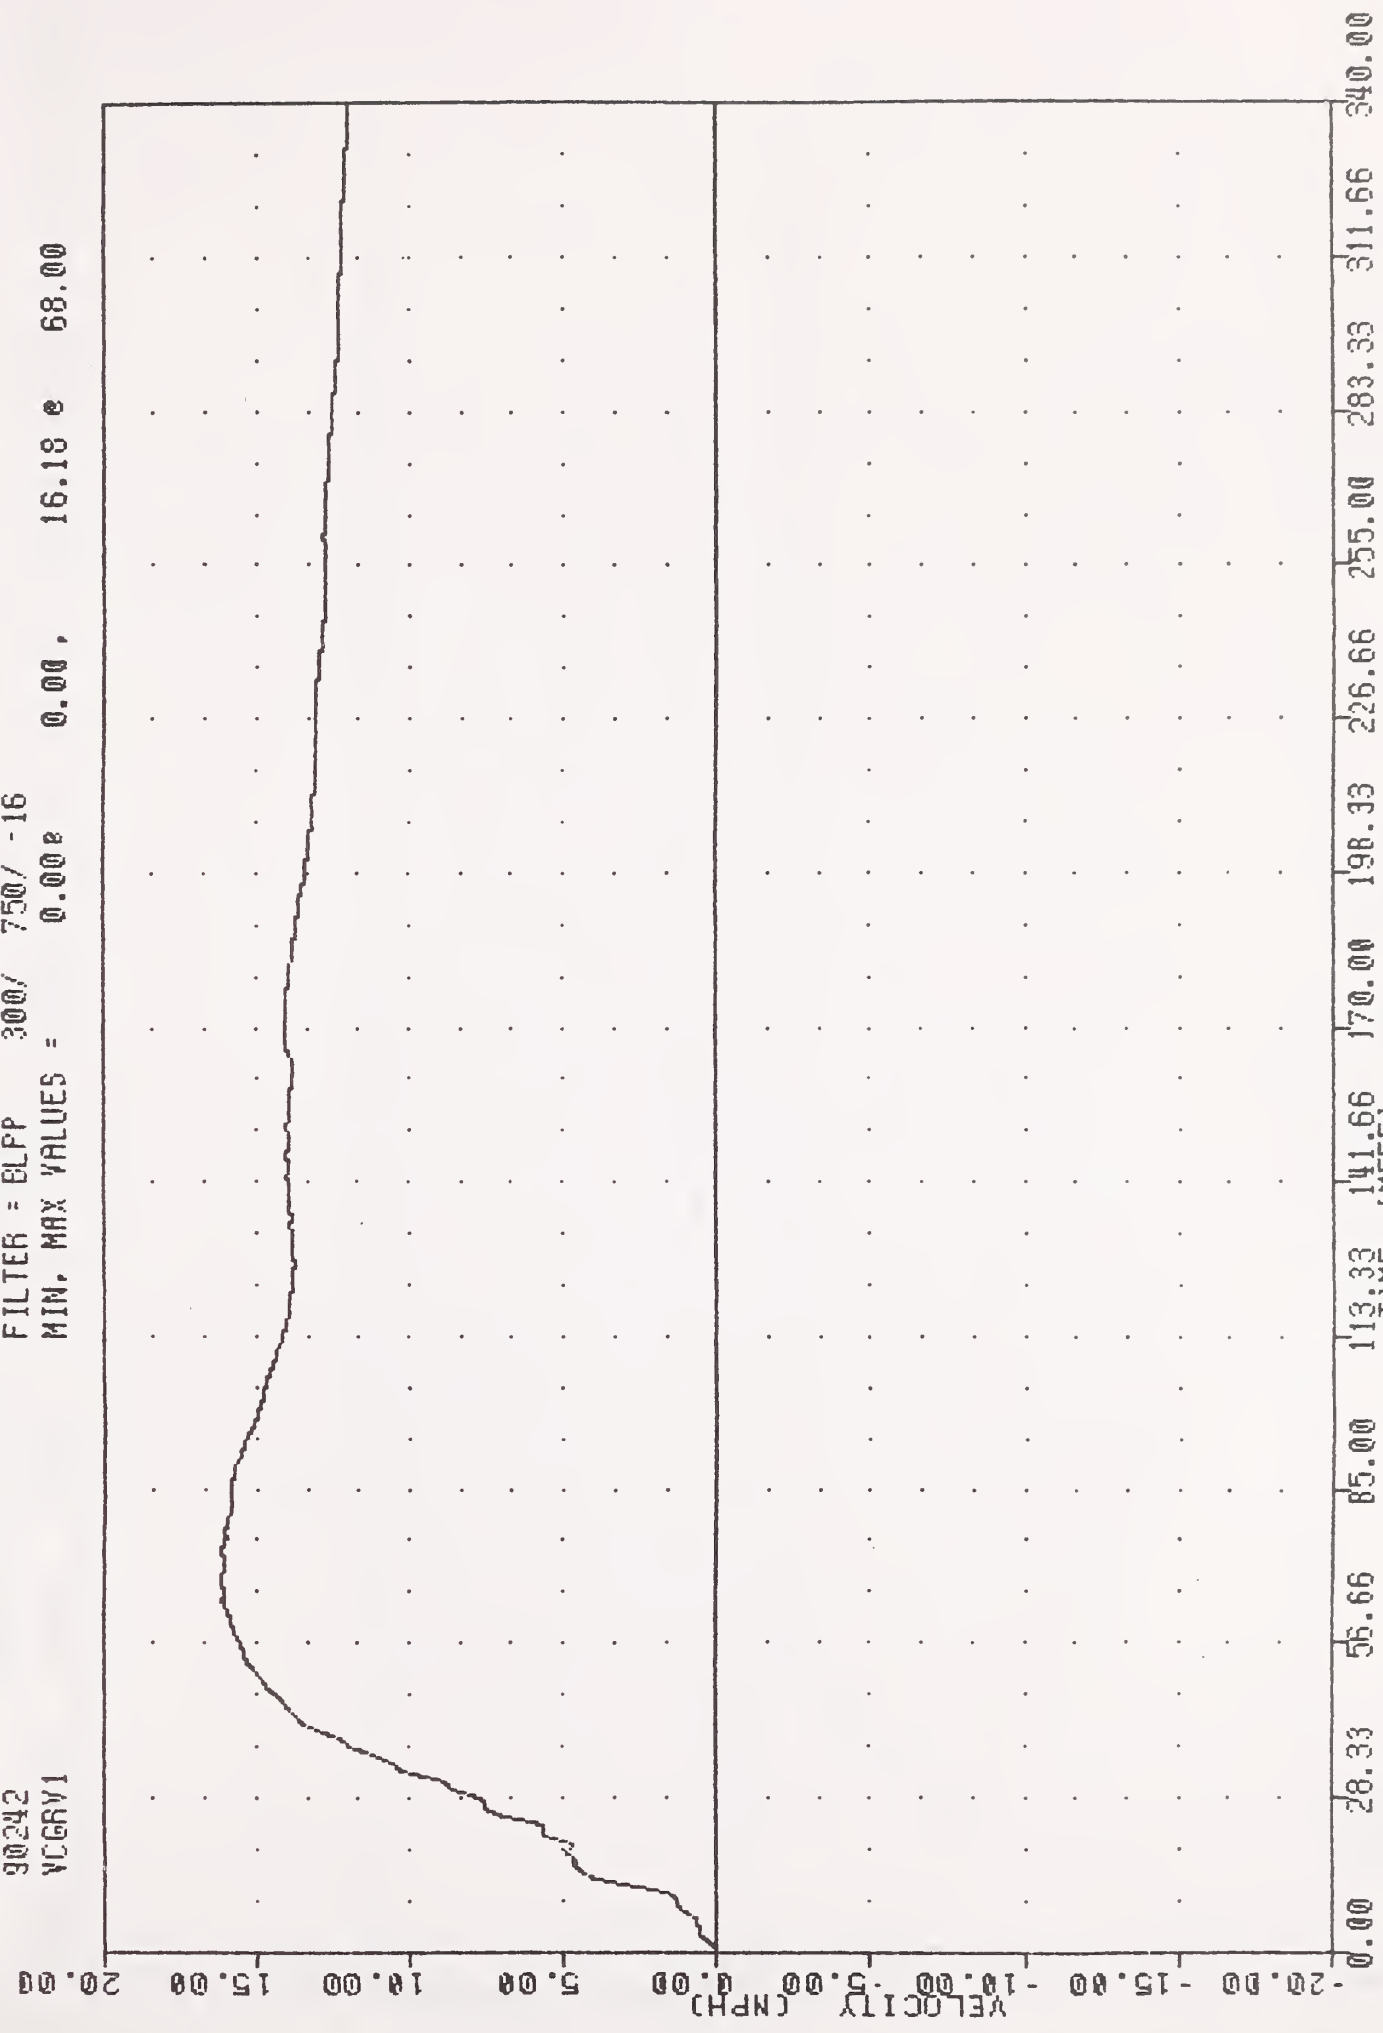
CONTOURED MOVING BARRIER INTO FORD ESCORT AT 28.3 MPH ±3
 VEHICLE CG RESULTANT VELOCITY

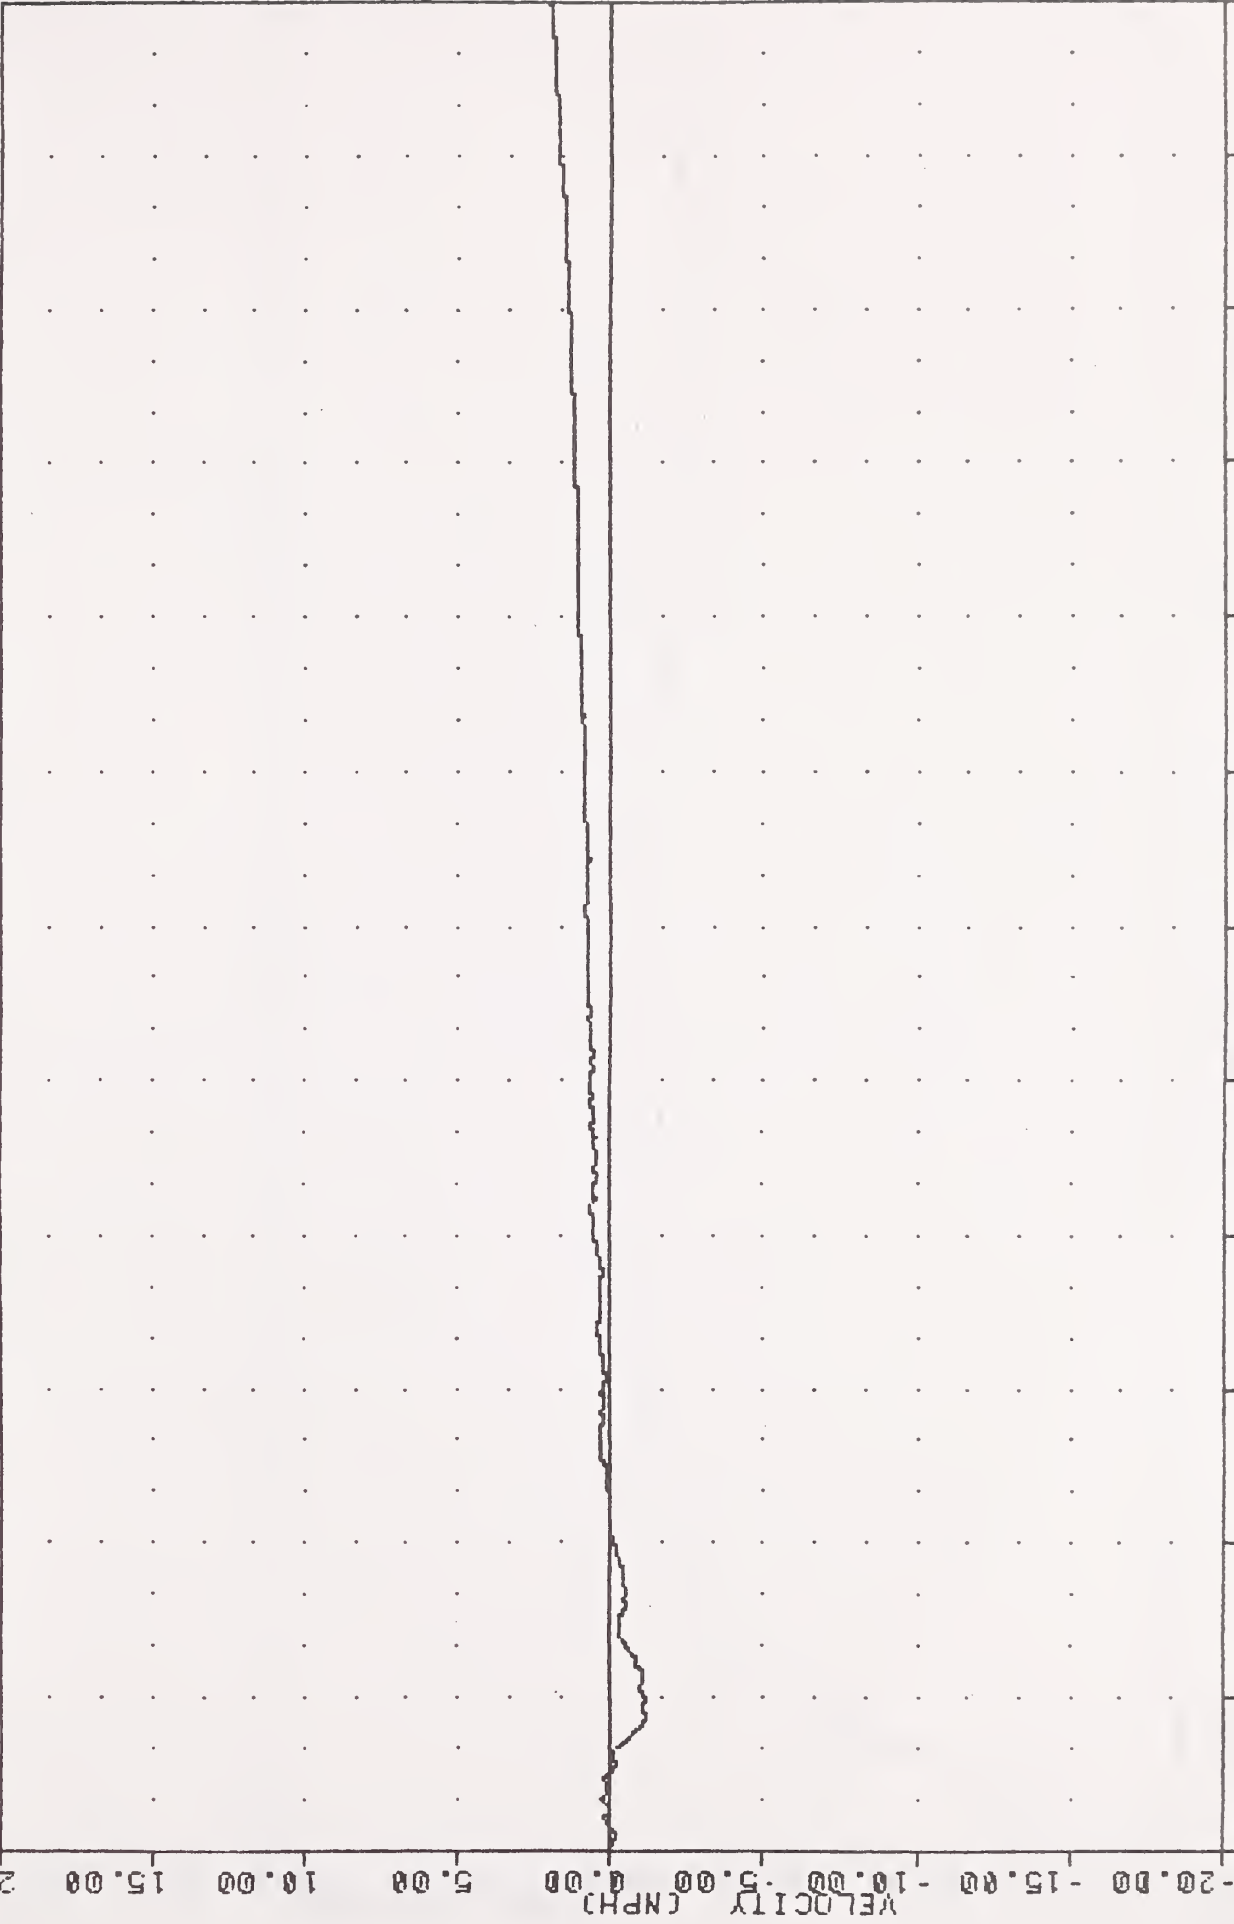
CONTOURED MOVING BARRIER INTO FORD ESCORT AT 28.3 MPH #3
 MOVING BARRIER CENTER OF GRAVITY Y-AXIS VELOCITY

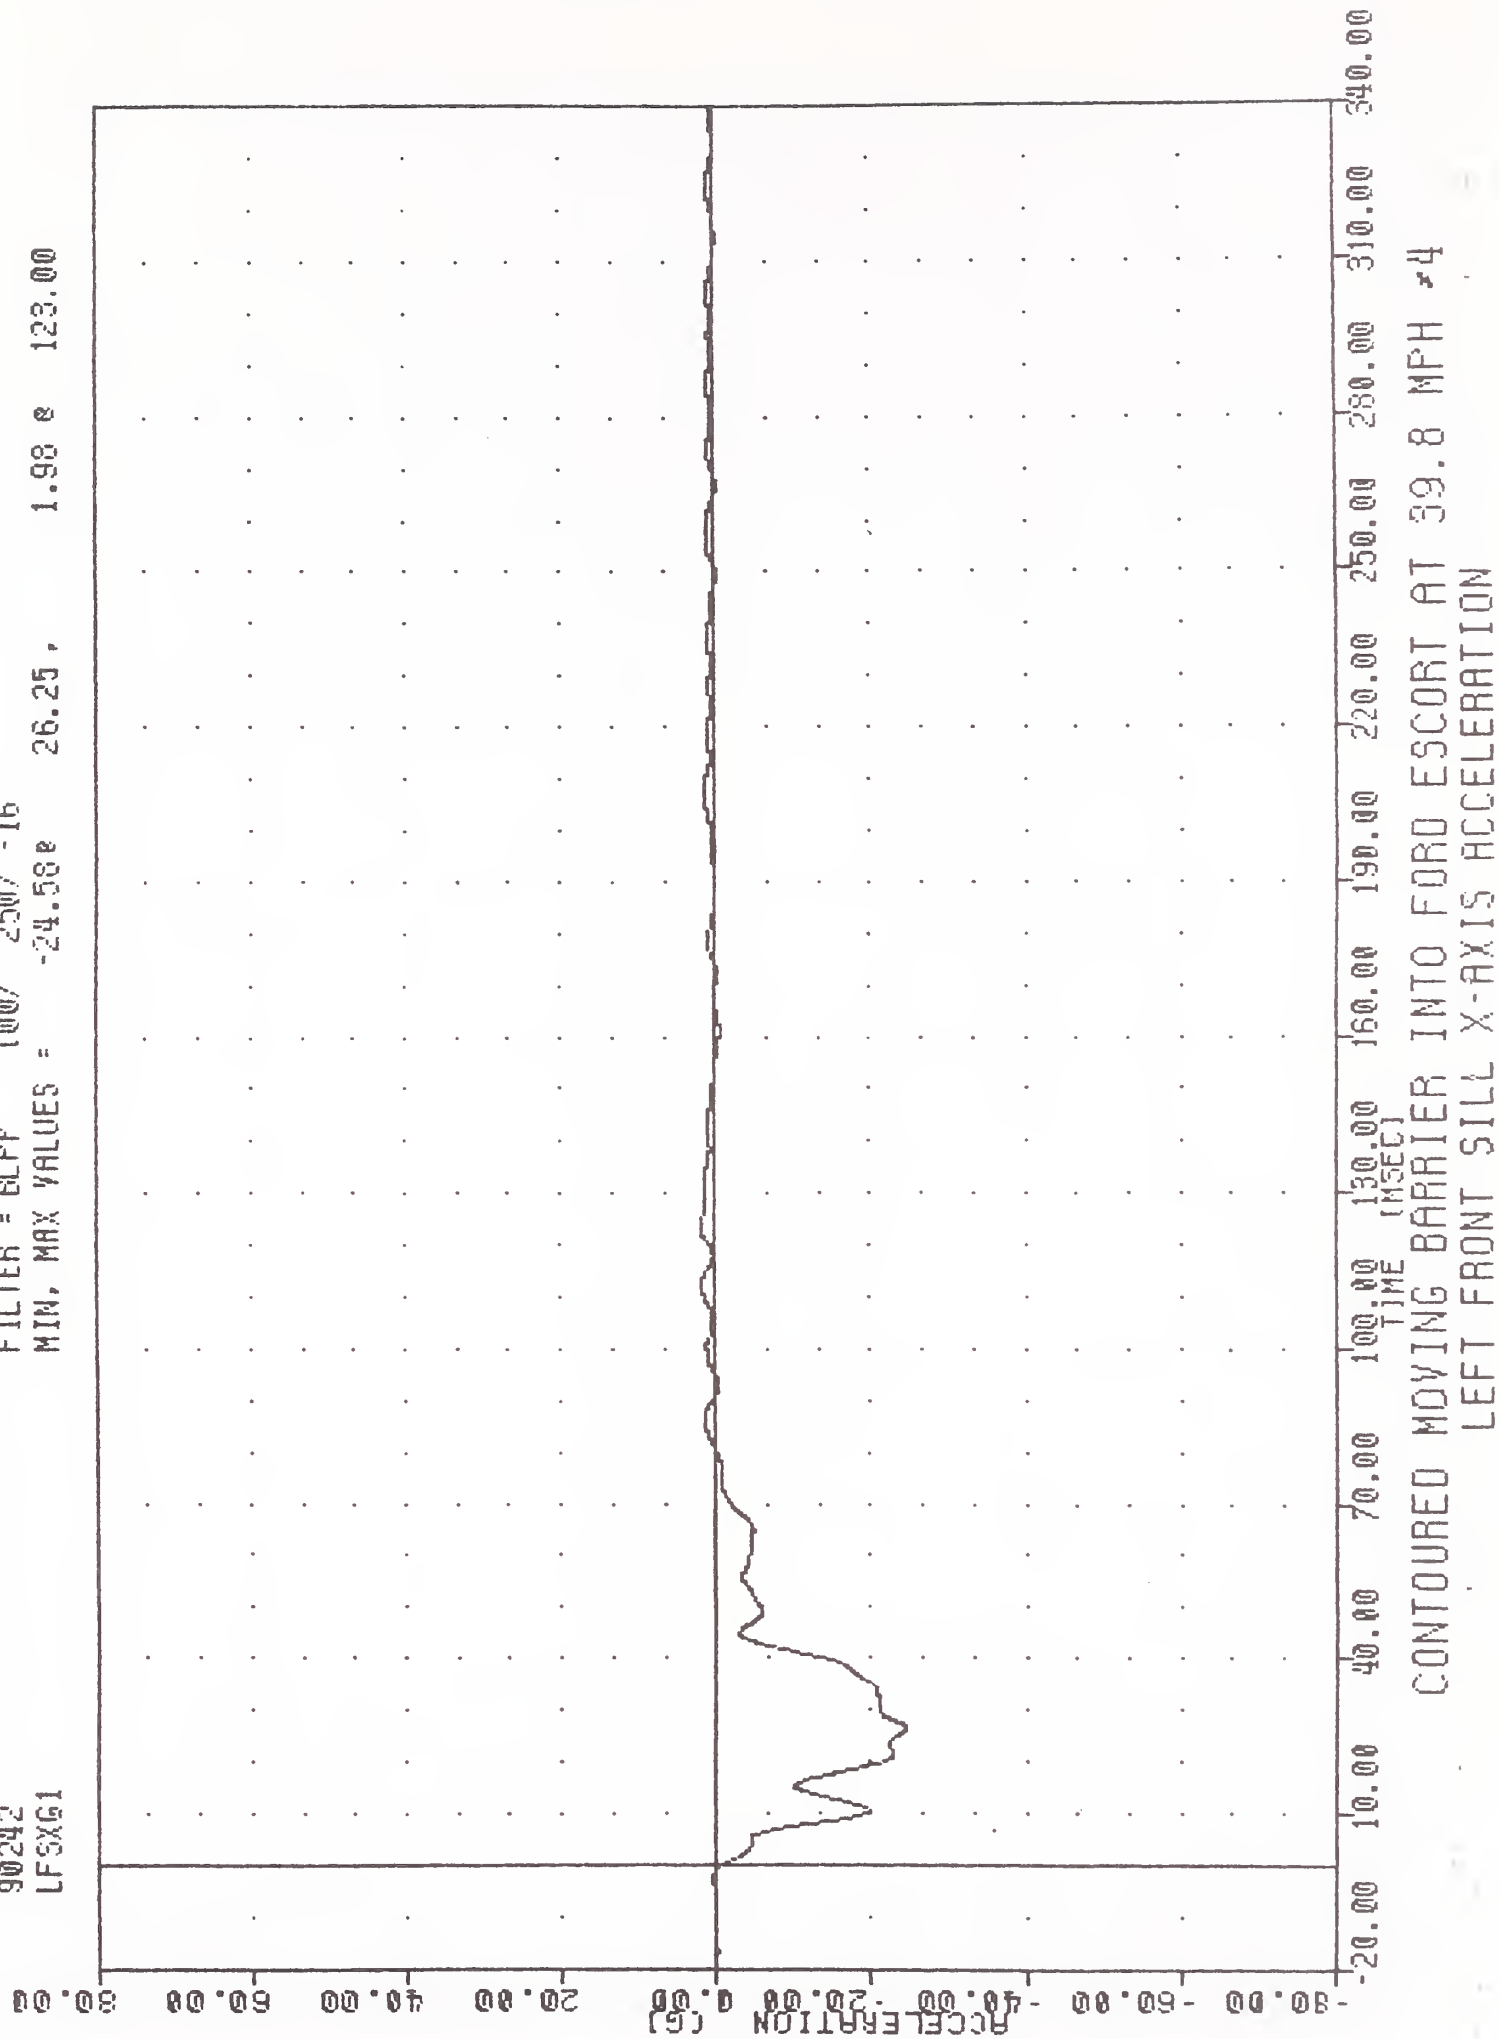
900330+4 .TAC
 CRASH III DAMAGE ALGORITHM
 90242
 LFSYG1

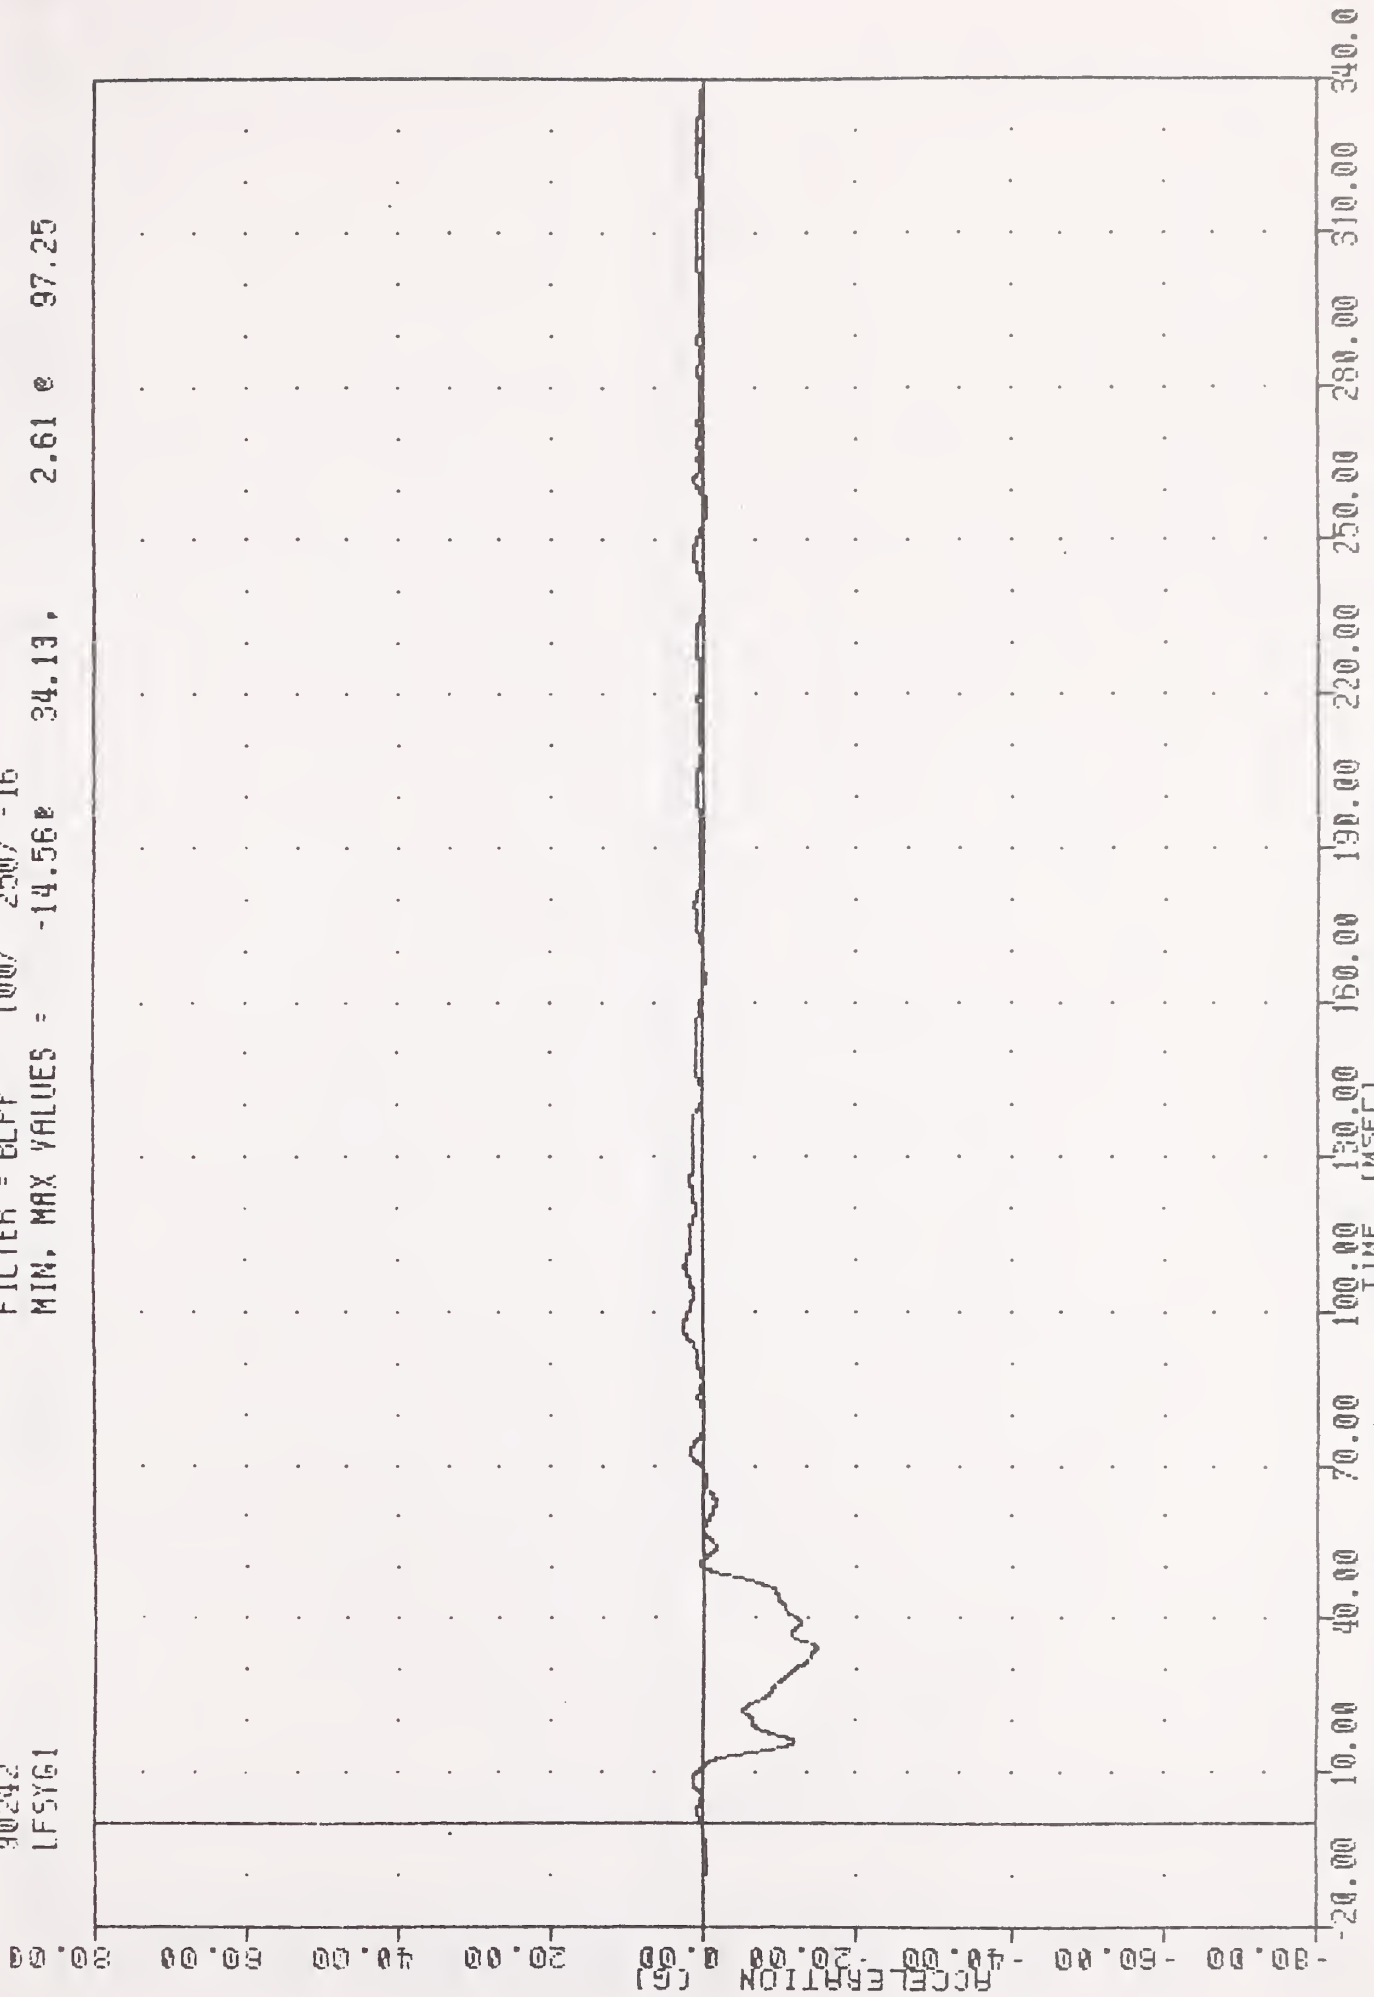
CONTOURED MOVING BARRIER INTO FORD ESCORT AT 39.8 MPH ±4
 LEFT FRONT SILL Y-AXIS ACCELERATION
